**FINAL REPORT ON THE ACCIDENT OCCURRED
ON 25 MAY 2008
AT BRUSSELS AIRPORT ON A BOEING
B747-209F REGISTERED N704CK**

Ref. AAIU-2008-13
Issue date: 10 July 2009
Status: Final

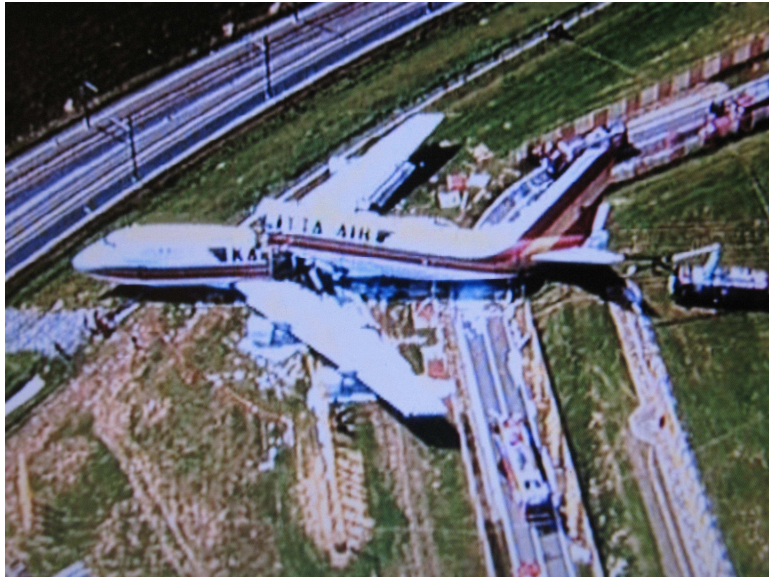
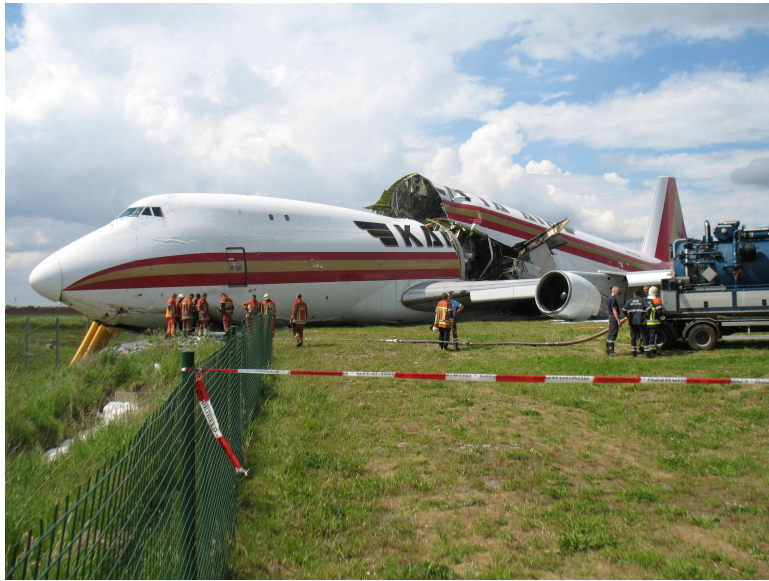
The entire fuselage was right side up at the accident site with severe impact damage and multiple skin, stringer and frame fractures. The fuselage fractured into three sections. The first major fracture of the fuselage – on the RH side – was located at about FS 1100 and the second at FS 2285.

The second section of fuselage, the fuselage skin, stringer, frame pressure deck and overwing longeron structure are raised up approximately 1.5 meter above the wing upper skin panel.

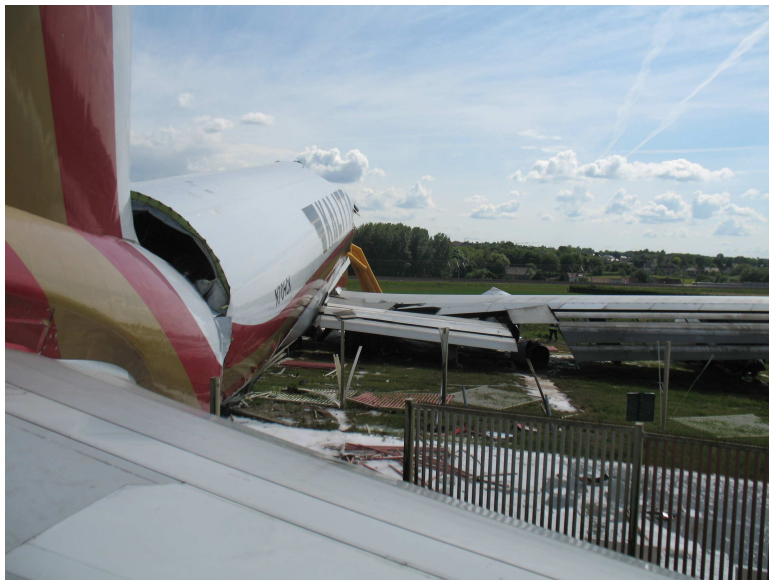
The main keel beam box was fractured just forward of the body landing gear drag brace support fitting. At the fracture, the aft keel beam is lifted up and separated from the forward keel beam.

The aft fuselage fracture was located at the tail section, just in front of the rudder.

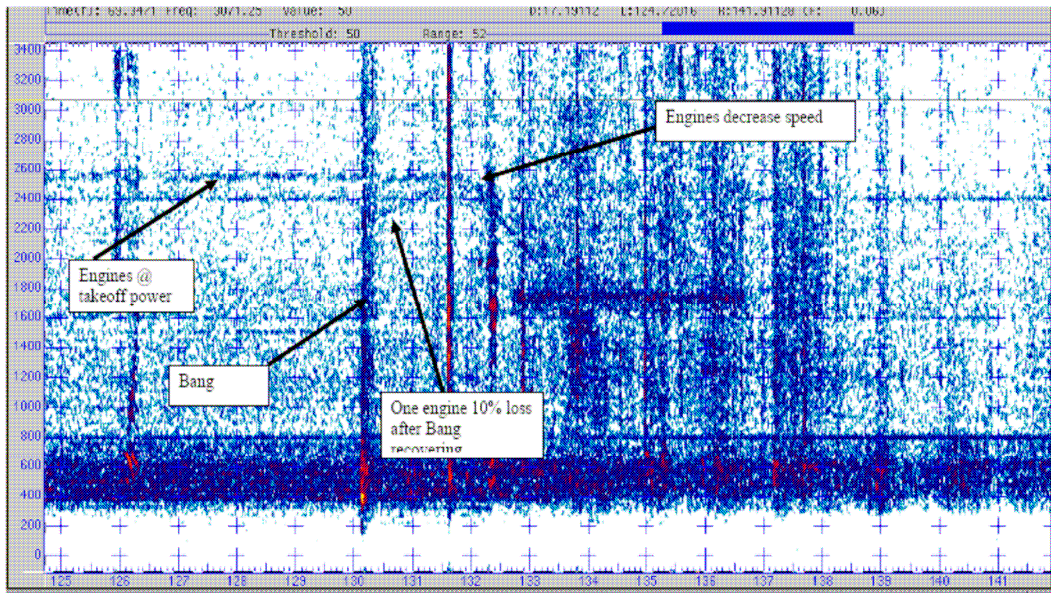
The analysis shows engine operating at take off power, then one (or more) is experiencing a loss of power, followed by a saturation (bang). The sound frequency is then moving to its original value, showing that the involved engine(s) is recovering, until the moment the power is reduced, by the pilot.

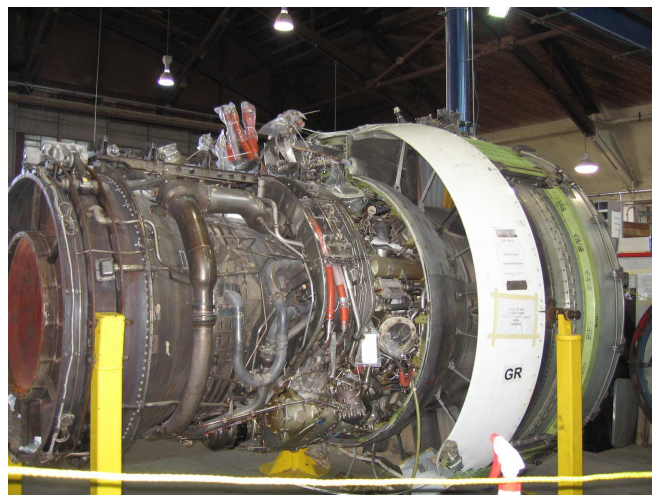
No impact marks or inward deformation of the front or rear spinners were noted. Fan blades Nos. 11, 35, 38 and 42 (86°, 273°, 297° and 328° respectively from index mark) exhibited soft body deformation with the leading edge pushed from the concave towards the convex side. The soft body damage was centered about 3-inches outboard from the platform. No impact marks or inward deformation of the fan exit fairing were noted.

The nine sound absorbing inner rear liner segments were removed from the engine and debris was removed from the inboard side of each screen and individually bagged. The bleed valve assembly was found in the open position (this should be the default position on engine shutdown). A large amount of debris (soil, vegetations, rocks, etc) was found at the 6:00 o'clock position of the fan case as well as in the bottom of the bleed valve linkage support. Centered around the 9:00 o'clock position (aft looking forward), a concentration of the organic material was stuck to the outside of the bleed linkage support, with the rest of the support exhibiting very little.

Organic debris was gathered from all nine sound absorbing inner rear liner segments, from each stage of the LPC stages, from fan blades 8, 9, 10, 19 and 20 and from bleed valve linkage support.

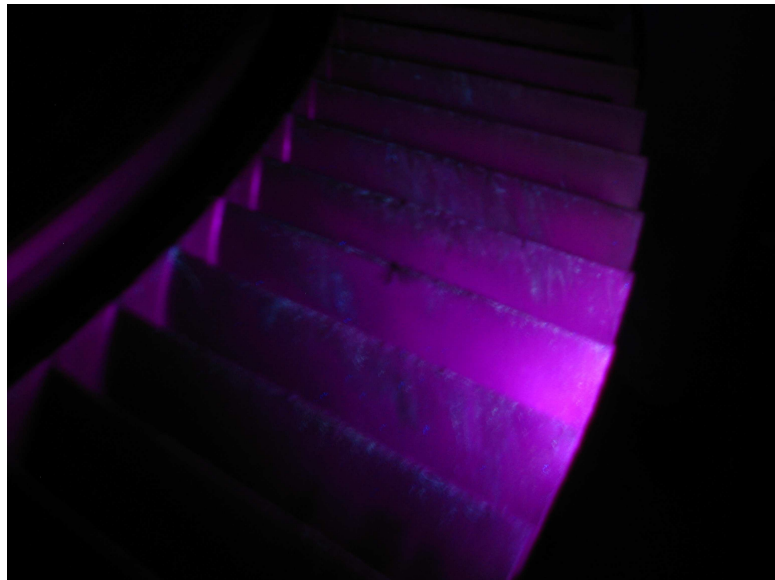
Black Light Inspection of Engine Nr3

The fan blades were inspected using a black light with the blades still installed in the fan disk. A **heavy and concentrated** organic smear and splatter in the axial direction on the concave side of the fan airfoils was observed at the platform between blades Nos. 31 & 32 and 32 & 33 (convex side) (242° from index mark). Blades No. 42 and 43 (329° from index mark) exhibited a light and more spread out organic smear and splatter on the airfoil concave with the smear flowing towards the blade tips. The blade numbering used are the blade numbers used during the initial installation and they sequentially increase clockwise forward looking aft.

Organic speckled material with no directional orientation was noted on the fan exit fairing around the 6:00 o'clock position. A black light inspection of the stage 1.5 low pressure blades revealed an organic smear of 6 consecutive blades on the concave side (pressure).

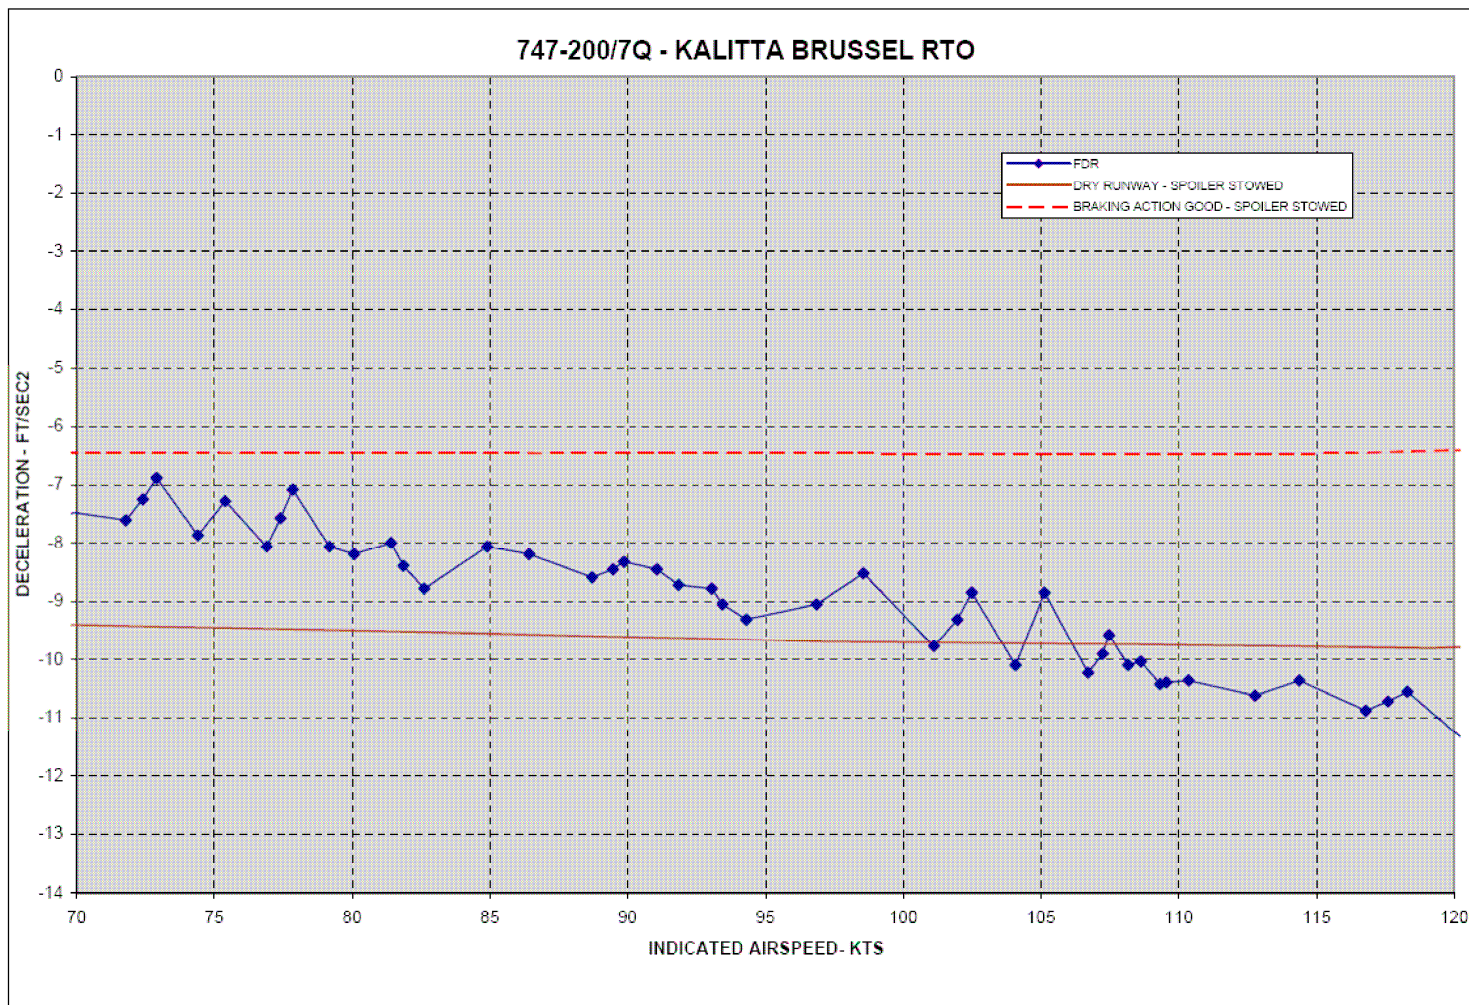
Figure 2: FDR deceleration in ft/sec2 as a function of indicated airspeed along with the estimated deceleration as a function of airspeed with spoilers stowed for both dry and wet runway.
