**FINAL REPORT ON THE ACCIDENT OCCURRED
ON 25 MAY 2008
AT BRUSSELS AIRPORT ON A BOEING
B747-209F REGISTERED N704CK**

Ref. AAIU-2008-13
Issue date: 10 July 2009
Status: Final

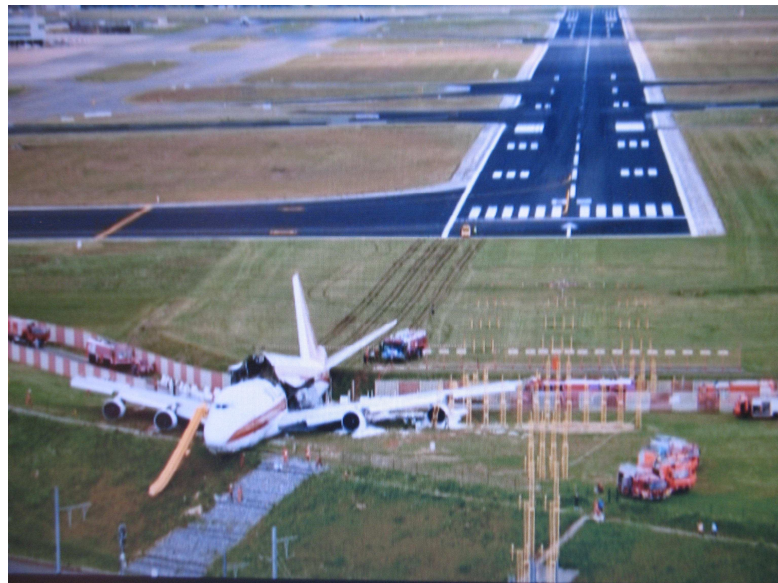
The aircraft reached a first embankment, dropping from a height of 4 m, and broke in three parts. The aircraft came to a stop just above the top of the railroad embankment.

The crew exited the airplane through the service door since the L1 door normally used was blocked due to deformation of the structure.

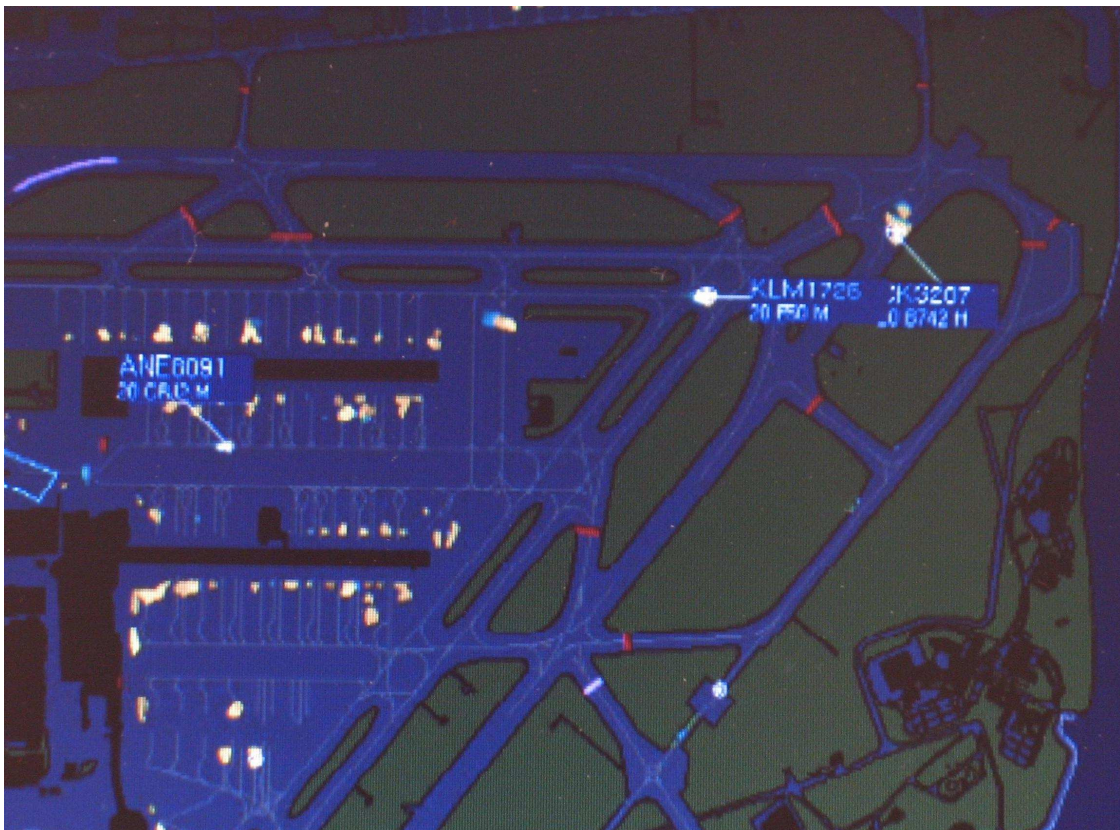
Ground radar image of CKS207 lining up on R20.

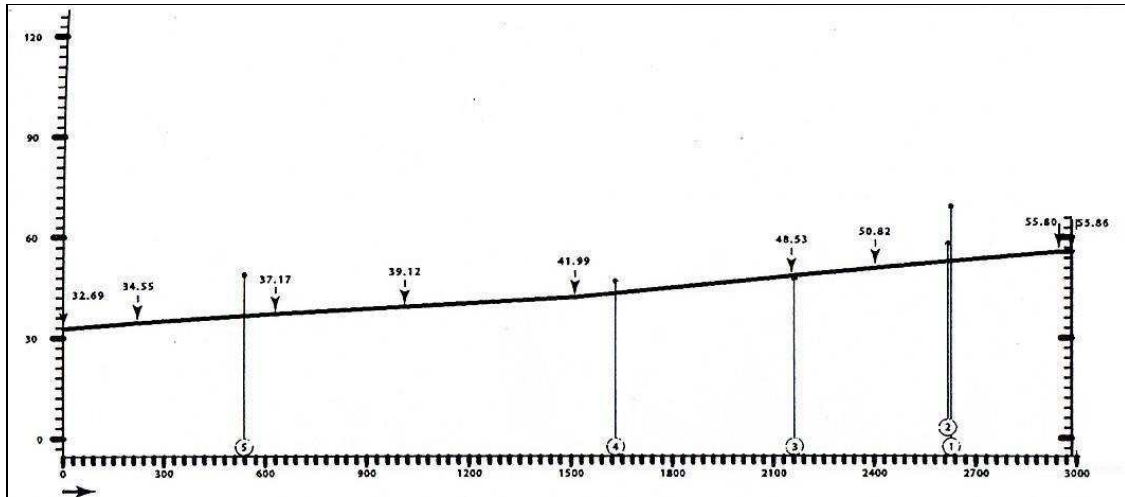
**Runway 20 - slope**

The slope on runway 20 is on average +0.78%; but from 0 to 1500m, the runway has a slope of 0.62, then for the remaining 1487m, it has an increased slope of 0.93%. Both values are complying with the ICAO recommended limits.

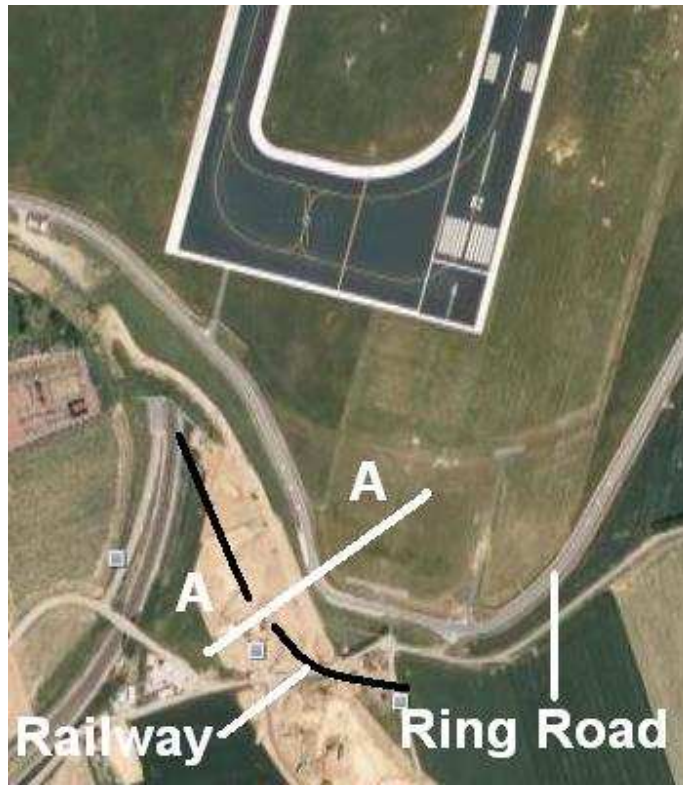
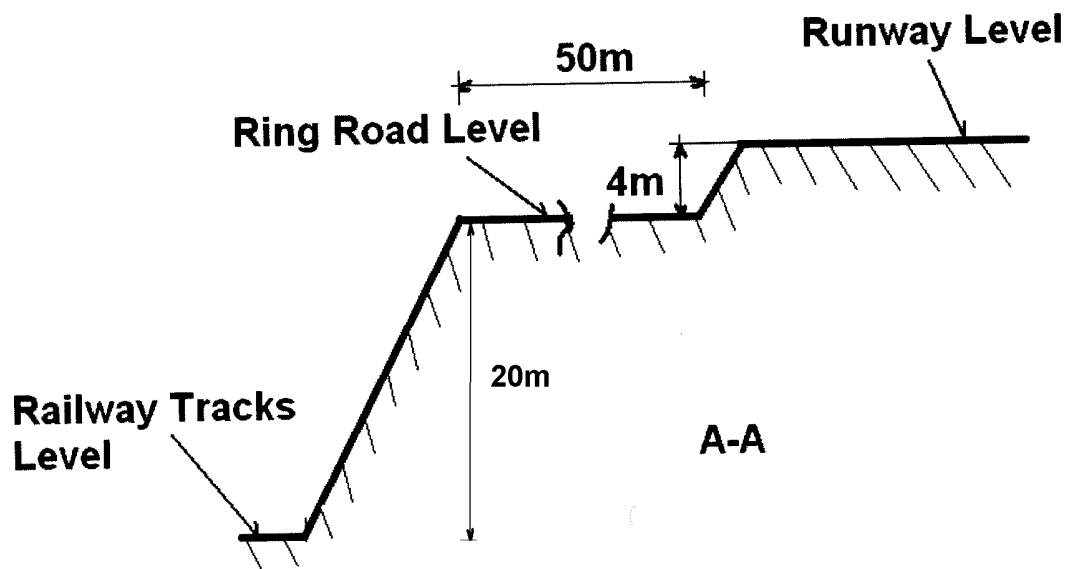
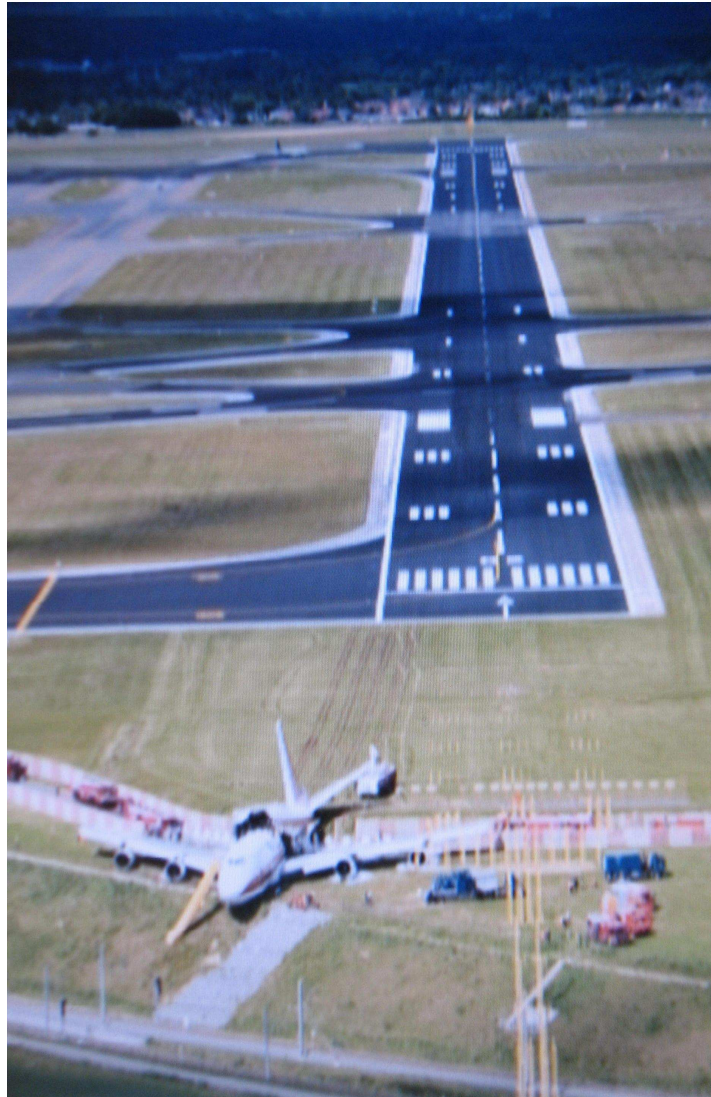
However, the same ICAO Annex 14 recommends to extend the length of the RESA to a distance of at least 240m. This recommendation (not mandatory) is not met for runway 20.

The runway is bordered by a road located 4m lower than the runway. The railroad tracks of the line Brussels – Leuven is 50 m further back, 20m lower than the ring road level.

The extension of the RESA seems difficult due to the presence of the railroad tracks, in the direction of R20 and roads in the opposite direction. The extension would involve serious costs.

A possibility to increase the efficiency of the RESA is to install an **Engineered Material Arrestor System (EMAS)** in order to create an additional braking effect.

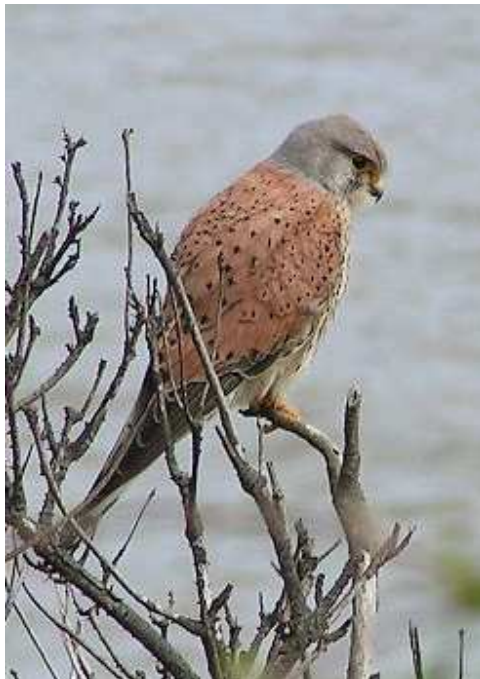
The results were consistent with the characteristics of the European Kestrel (*Falco Tinnunculus*).

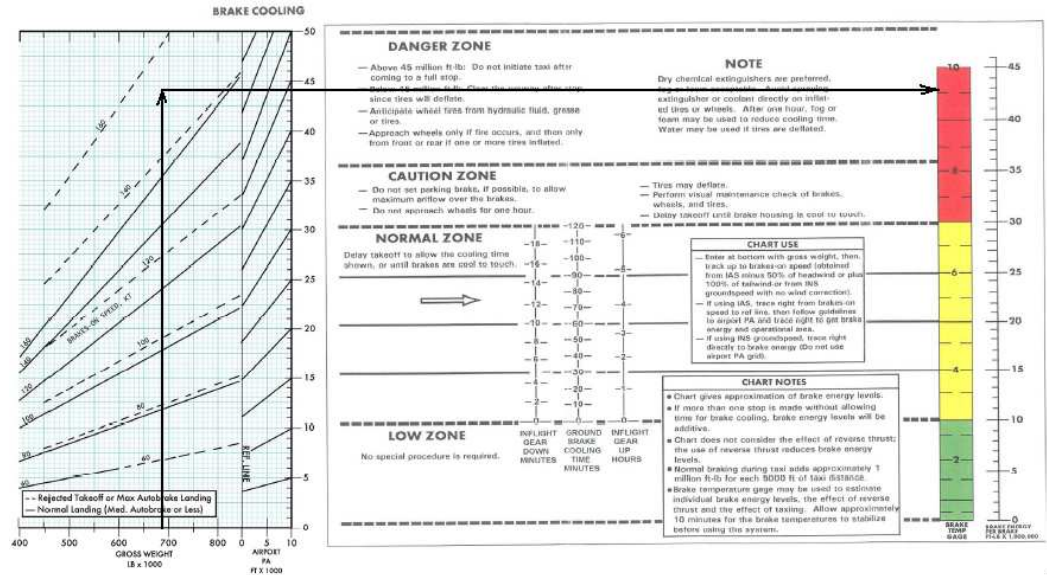
The Boeing B747 brake energy chart for aborted takeoff or maximum braking shows an accumulated energy of 44.10⁶ ft-lbs (maximum speed 152kts). The maximum available brake energy level is 45.10⁶ ft-lbs. This level is in the danger zone of the brake energy chart, where tires are likely to deflate and wheel fires must be anticipated.

On the wreckage, 14 out of 16 tires were found intact after the aircraft was stopped.
